**Title:** Friction stir weld restart+reweld repair allowables**Summary:**

# **Friction Stir Weld Restart+Reweld Repair Allowables**

**Andrew Clifton  
Materials Engineer  
Lockheed Martin  
Michoud Operations  
504-257-3547  
[Andrew.C.Clifton@lmco.com](mailto:Andrew.C.Clifton@lmco.com)**

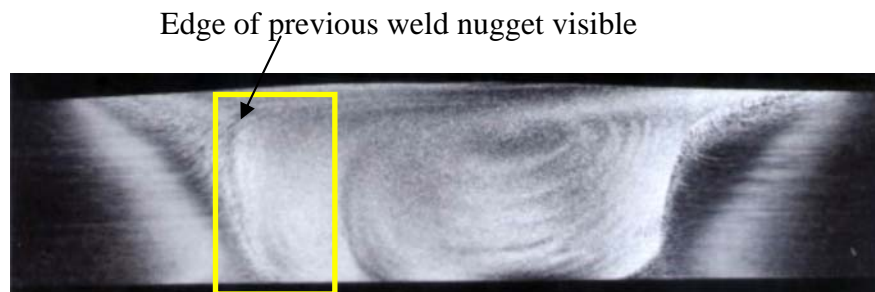
**Figure 1. Three pass reweld macro (3X magnification).**

Macros were taken from R+R panels and analyzed. A representative macro is shown in Figure 1. The presence of multiple weld passes is clearly seen. No rejectable indications were seen in macros.

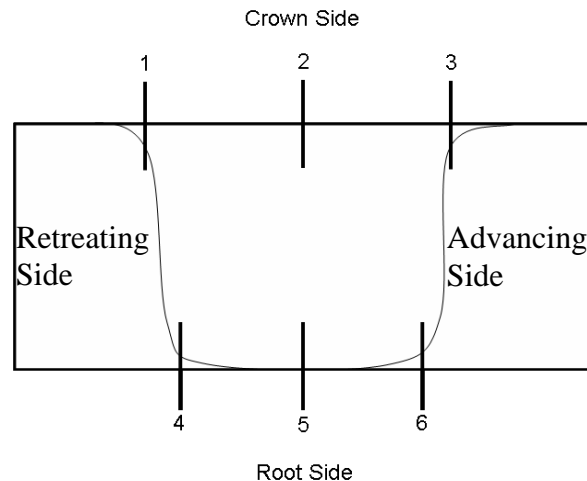
**Figure 2. Pre-crack flaw locations.**

Simulated service test (SST) specimens were used to test the multi-pass FSW (2 pass and 3 pass) as well the as restart locations (restart in an initial FSW and restart in reweld). The weld restart location, if present, was centered in the width of the specimen. A 0.15 inch deep (a) X 0.75 inch long (2c) pre-crack flaw was used for SST. Pre-crack flaws were tested in six locations in the weld repairs as shown in Figure 2.

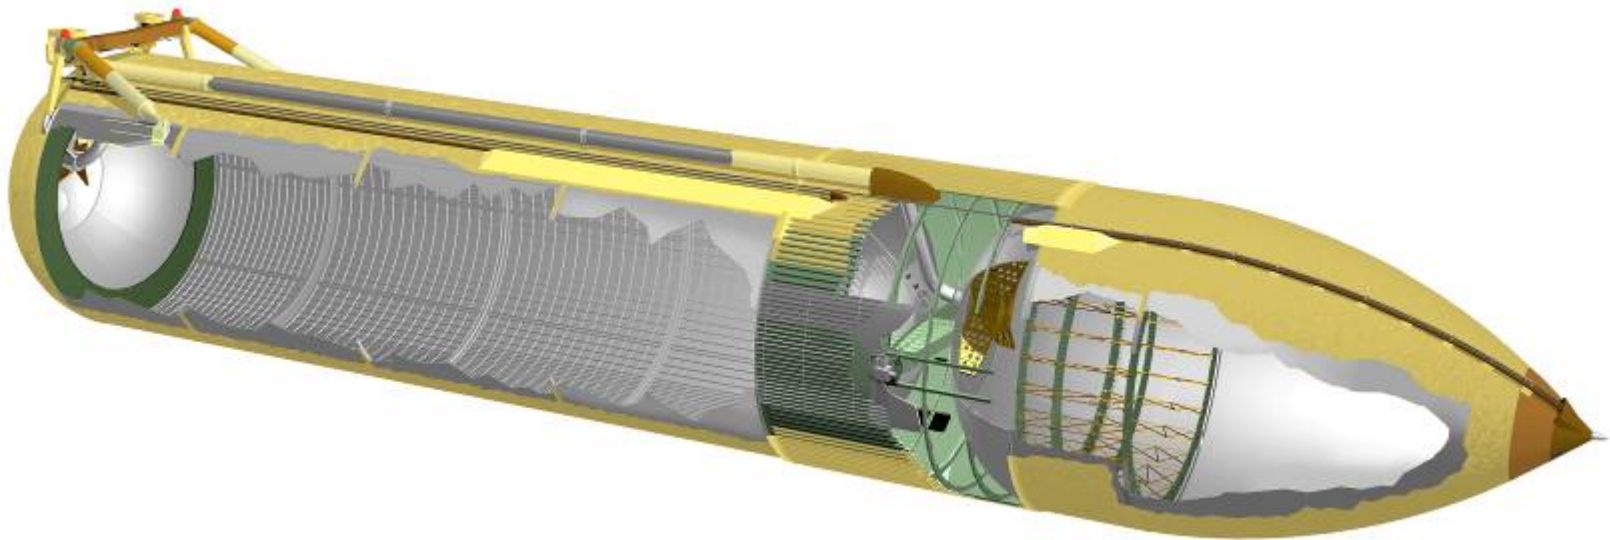
- **Cutaway view of External Tank:**

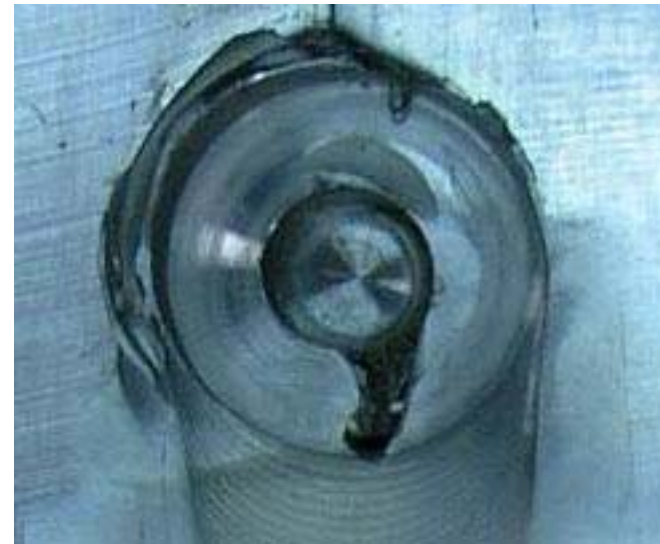
- **Unscheduled weld termination causes a hole where the pin tool stopped**
- **Development testing led to a standard repair methodology:**
  - **Restart the FSW in the termination hole**
  - **Complete initial weld**
  - **Complete two reweld passes through initial weld**

**Termination hole left by friction stir weld**

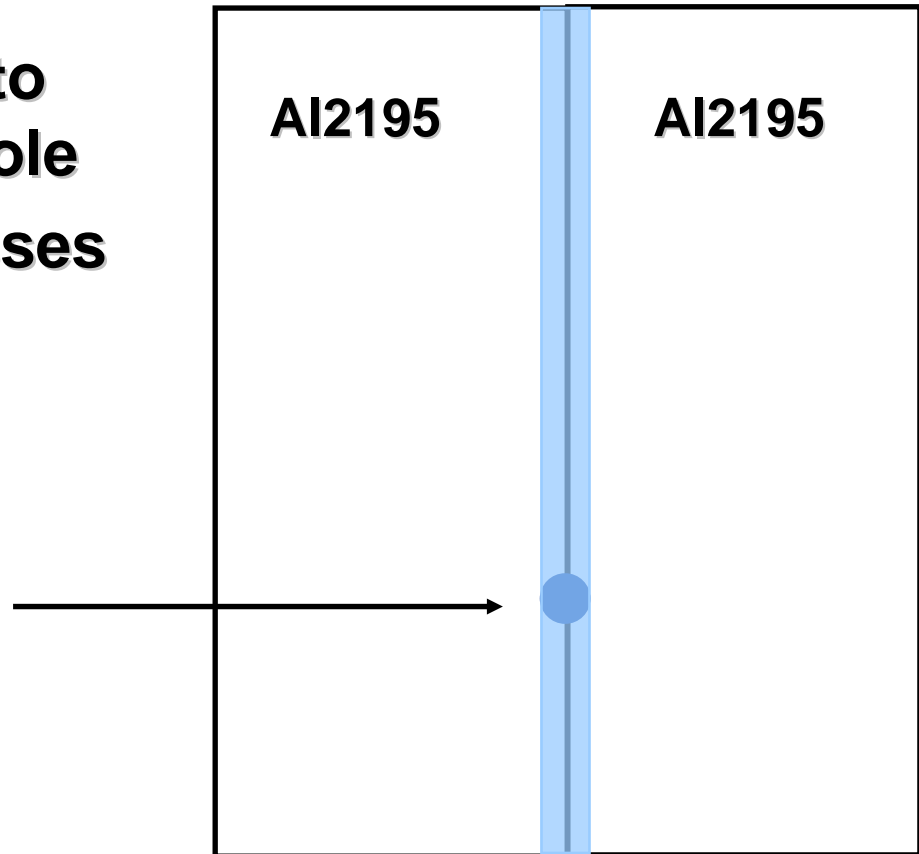
- Weld restarted in termination hole
- Two reweld passes to repair termination hole
- Three total weld passes

Termination hole  
in initial weld

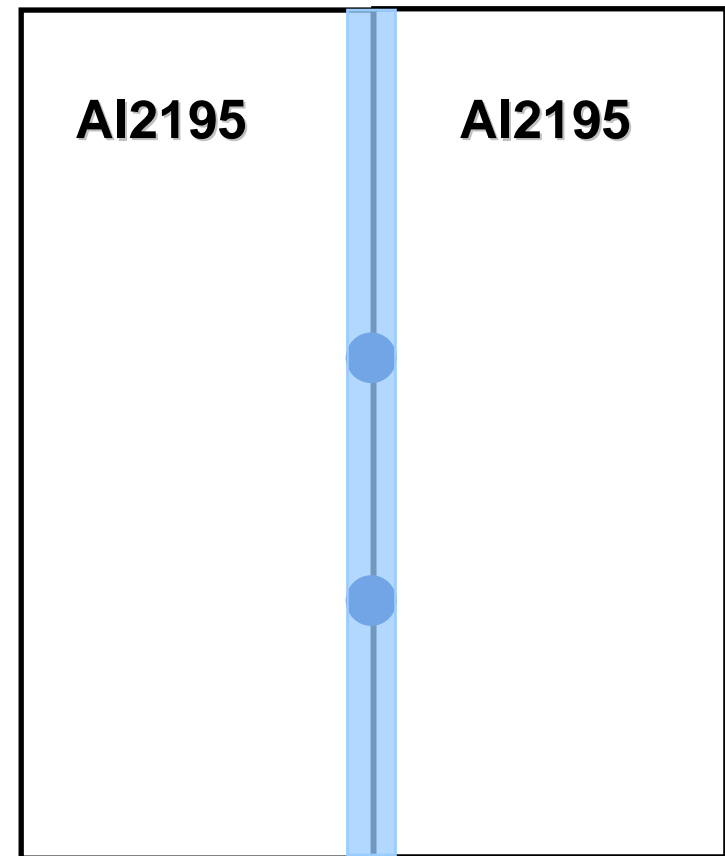
- **Weld restarted in termination hole**
- **Termination in first reweld**
- **Restart the first reweld**
- **Two additional reweld passes**
- **3 full-length reweld passes**
- **Four total weld passes**

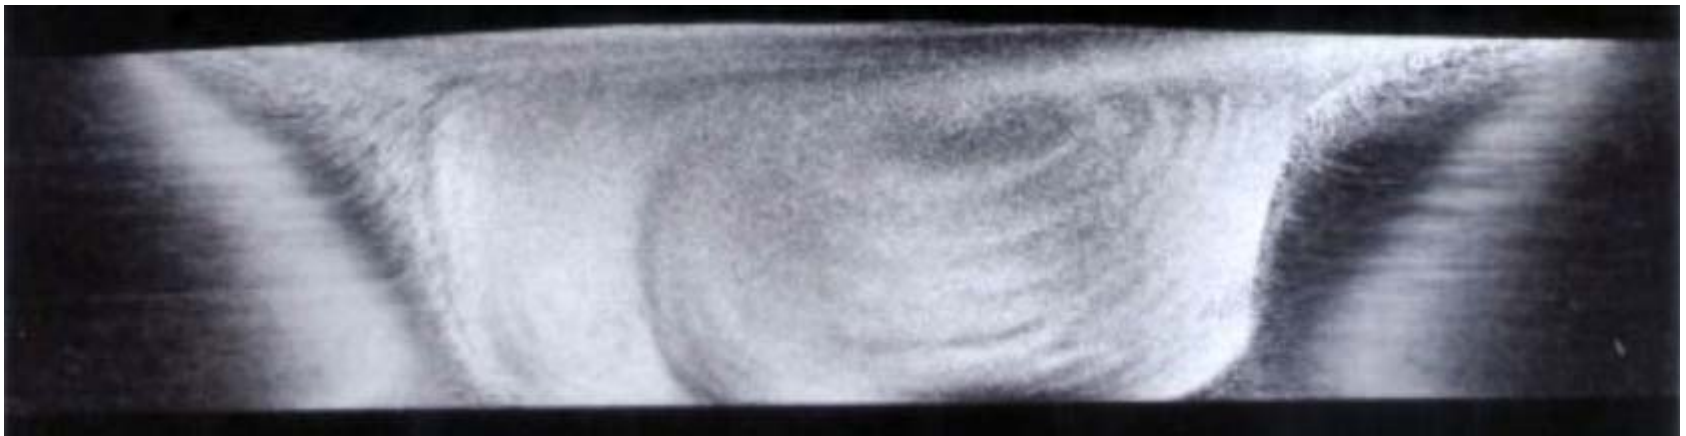
- One macro from each panel – 16 total
- No rejectable indications in macros (typical below)

**No metallographic defects due to R+R repairs**

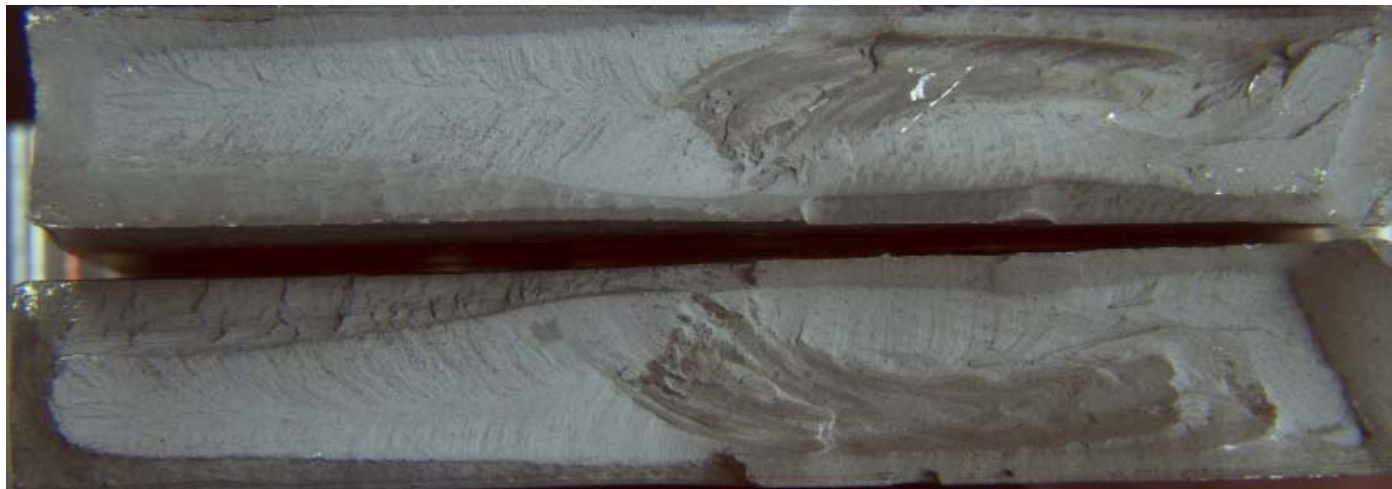
- **A-basis calculated for repaired welds:**
  - No reduction in room temperature UTS
  - 5 ksi lower than initial weld at at -423°F
- **Representative fracture face showing restart location:**

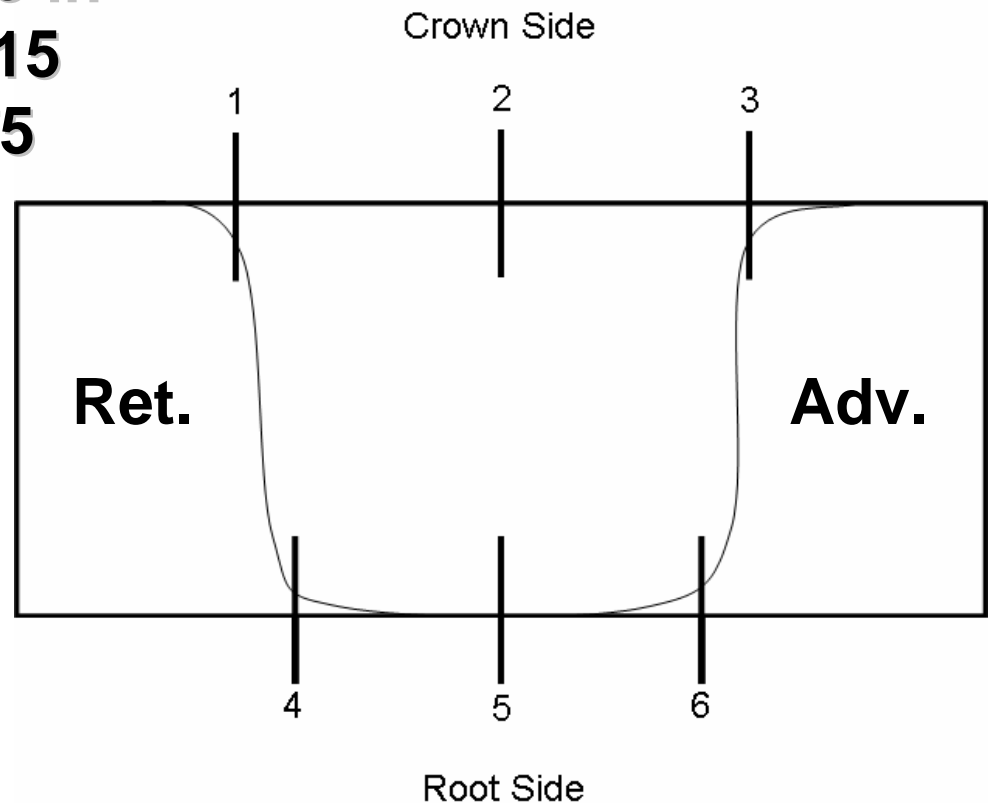
- Three inch gage width specimens
- Pre-crack flaw made in each specimen – 0.15 inch deep (a) by 0.75 inch long (2c)
- Flaw at one of six locations:

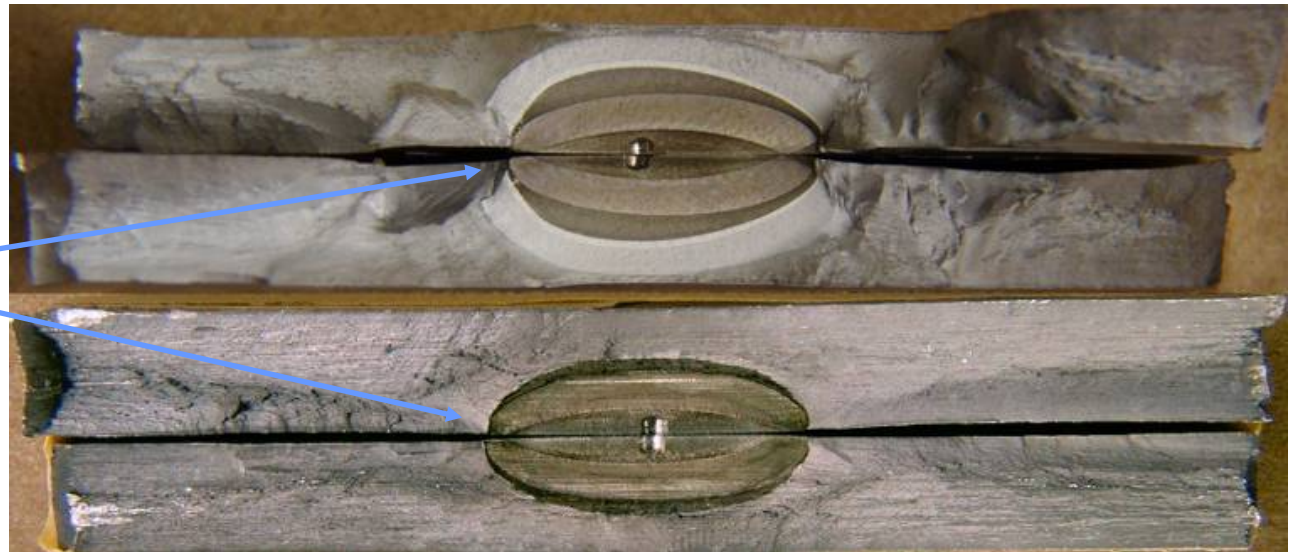
**pre-cracks**

- **Thirty specimens tested**
- **Standard R+R and Repaired R+R tested, including termination locations**
- **SSTs performed at room temperature and -423°F**

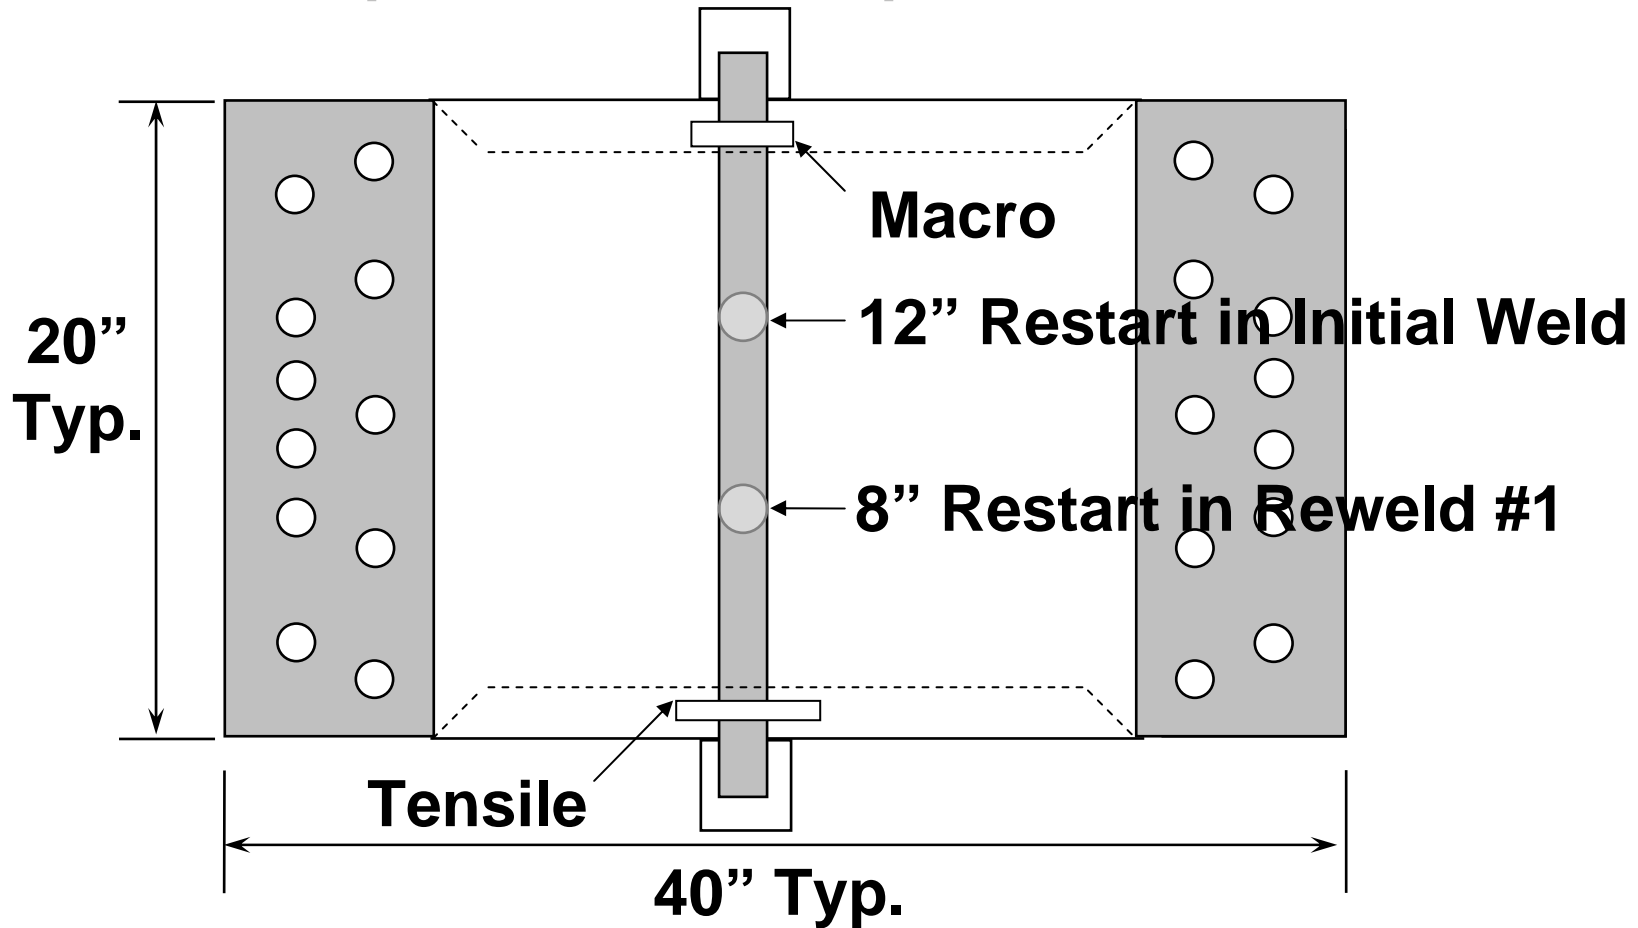
- Four Repaired R+R wide panels:

Four wide panels were welded and tested for strength and to evaluate residual stresses. Wide panel specimens were ~40 inch long by ~20 inch wide welded panels machined to a dog-bone configuration, yielding 15 inch gage width for testing.

Each wide panel contained an initial weld and two restart welds spaced evenly within the 15 inch initial gage width. A 3 pass FSW reweld was performed on each wide panel. No pre-crack flaws were induced in these panels.

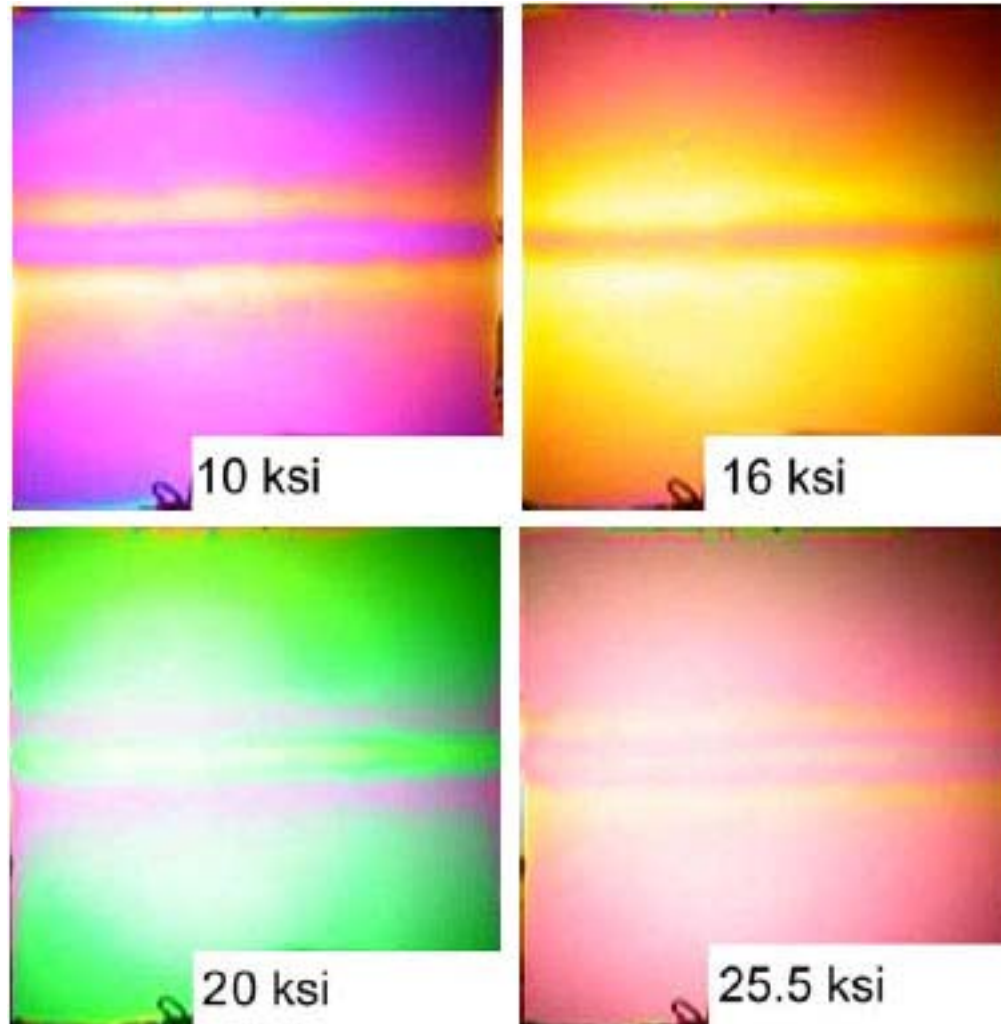
# Wide Panels – Photostress

- **Each panel proof tested to 30 ksi, followed by radiographic and penetrant inspections**
- **Tested to fracture to measure strength**
- **All panels radiographically acceptable to tightest criteria (indications less than 0.065 inch)**
- **All panels met minimum design values for initial welds**
- **Photostress analysis showed no stress concentrations**

All wide panels met the minimum design strength requirements. All panels were radiographically acceptable with indications less than 0.065 inches (if present). Photo stress analysis was performed on one wide panel while being tested to fracture. No stress concentrations at the restart locations or in the rewelds were seen. This confirms that there were no significant visible stress concentrations in the wide panel due to the restarts or rewelds.

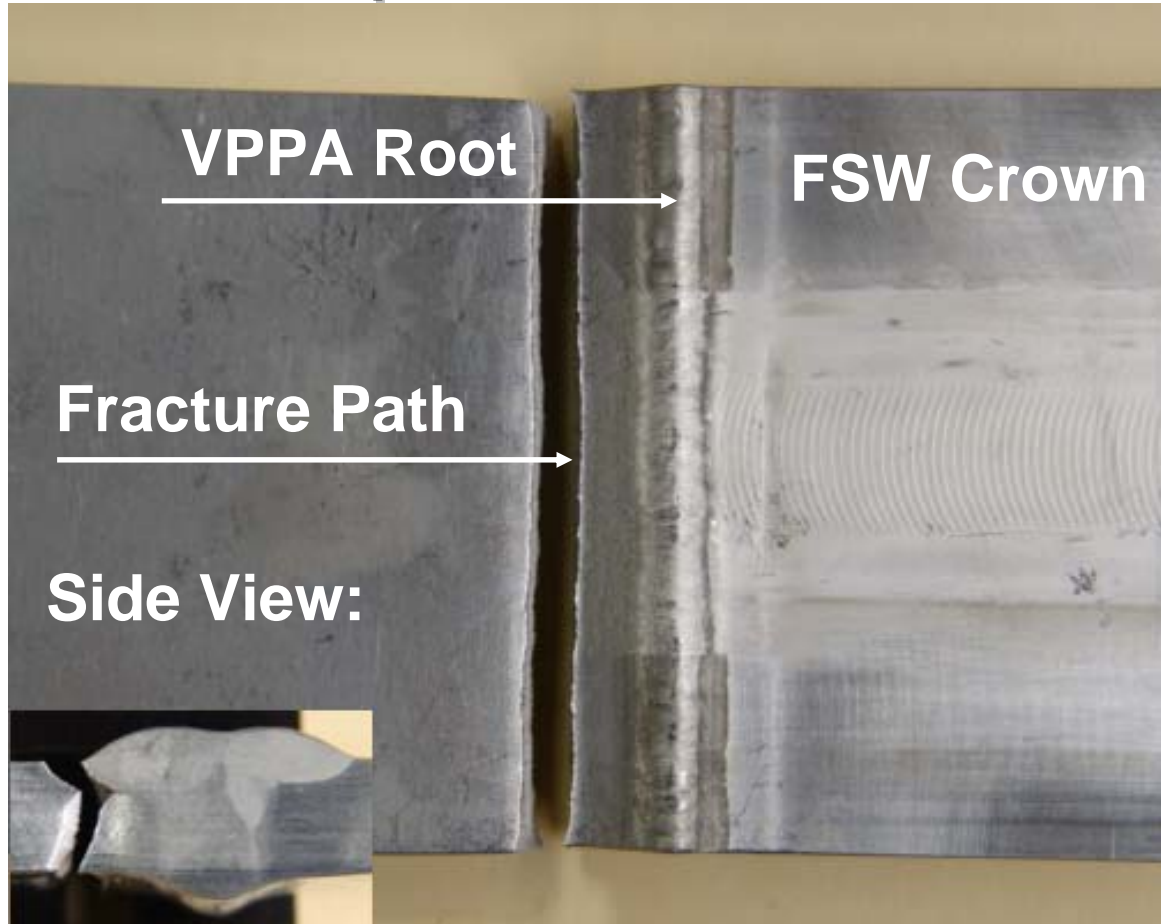
- **Typical fracture path:**

- **All intersections exceeded design strength requirements**
- **All specimens fractured on 2219 side of specimen opposite FSW except for one specimen containing 0.6 inch porosity at fusion root toe**
- **Porosity up to 0.7 inch tested “as is” and did not adversely affect strength**
